DEPARTMENT OF TRANSPORTATION

Quality Assurance and Source Inspection

Contract #: 04-0120F4Cty: SF/ALA Rte: 80 PM: 13.2/13.9File #: 1.28**WELDING INSPECTION REPORT****Resident Engineer:** Casey, William**Address:** 333 Burma Road**City:** Oakland, CA 94607**Report No:** WIR-028599**Date Inspected:** 17-Oct-2012**Project Name:** SAS Superstructure**OSM Arrival Time:** 700**Prime Contractor:** American Bridge/Fluor Enterprises, a JV**OSM Departure Time:** 1730**Contractor:** American Bridge/Fluor Enterprises, a JV**Location:** Job Site**CWI Name:** See below.**CWI Present:** Yes No**Inspected CWI report:** Yes No N/A**Rod Oven in Use:** Yes No N/A**Electrode to specification:** Yes No N/A**Weld Procedures Followed:** Yes No N/A**Qualified Welders:** Yes No N/A**Verified Joint Fit-up:** Yes No N/A**Approved Drawings:** Yes No N/A**Approved WPS:** Yes No N/A**Delayed / Cancelled:** Yes No N/A**Bridge No:** 34-0006**Component:** OBG**Summary of Items Observed:**

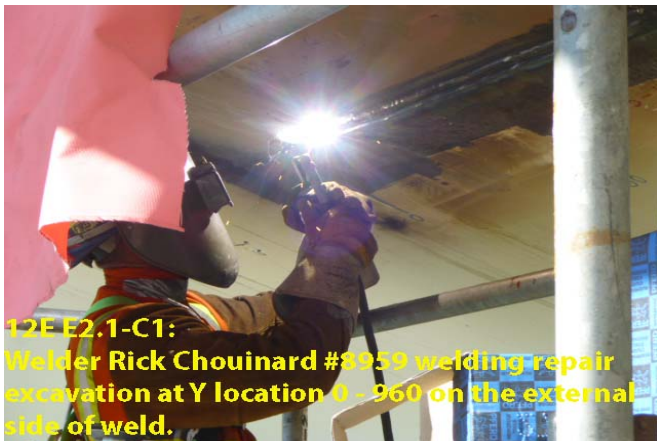
Welder was observed performing weld repairs on weld 12E E2.1-C1 externally, on Ultrasonic Testing Shear Wave (UTSW) rejected indications noted by QC Inspectors at Y location 0 - 960. Welder was observed utilizing Caltrans approved Welding Procedure Specification's (WPS) ABF-WPS-D15-1000R Rev.2 for Shielded Metal Arc Welding (SMAW). The welder was observed preheating the welds prior to Carbon Arc Gouging and welding. Other welding parameters as inspected by QC Inspector William Sherwood appear to be in compliance with the WPS noted above.

Welder was observed welding on the Main Span Stage 3 Deck Anchor attachment welds to the "A" deck at panel point 102 west side. Welder was observed utilizing Caltrans approved Welding Procedure Specification's (WPS) ABF-WPS-D15-F2200-2 for the 2F position and F2300-3 for the 3F position. The welder was observed preheating the welds prior to welding. Other welding parameters as inspected by QC Inspector Fred Michaels
